CASE STUDY: HEMLOCK CREEK

Hemlock, or Wood, Creek is a tributary to Tinker’s Creek that runs through Bedford, Walton Hills, and Maple Heights. Hemlock Creek has a drainage area of 3.6 square miles. Cleveland Metroparks has been monitoring Hemlock Creek using the BEHI because the creek has been experiencing in-stream erosion due to stream channel incising, lack of access to the floodplain, stream bank stabilization, and fallen trees due to under-cutting. 3626.8 feet (59.8%) of this creek were not ranked because they did not meet the requirements of the pre-questionnaire. The remaining segments of the creek scored as follows:

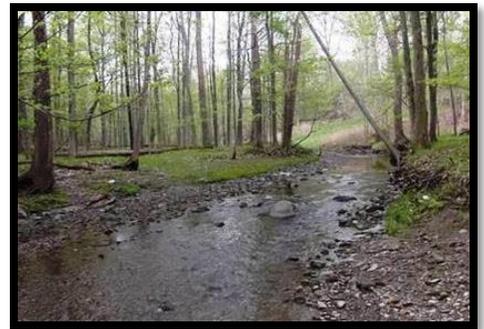
- Low Erosion:** 91.89 ft. (1.5%)
- Moderate Erosion:** 683.33 ft. (11.3%)
- High Erosion:** 1053.19 ft. (17.4%)
- Very High Erosion:** 345.01 ft. (5.7%)
- Extreme Erosion:** 262.62 ft. (4.3%)

Average Metric Scores for Hemlock Creek*			
Rating:	High	Root Value:	47.69
Score:	27.27	Density Score:	6.65
Segment Height:	5.45 ft.	Density Value:	24.52
Segment Length:	74.12 ft.	Angle Score:	68.81
Materials Score:	1.98	Angle Value:	5.39
Stratification Score:	2.75	Surface Score:	6.24
Root Score:	4.79	Surface Value:	32.69

This score indicates that Hemlock Creek is highly susceptible to erosion and may be at risk of bank failure as a result. Based on only humidity, Hemlock Creek would therefore be a priority area for remedial actions.
