Tinker's Creek Watershed

2019 Water Quality Report

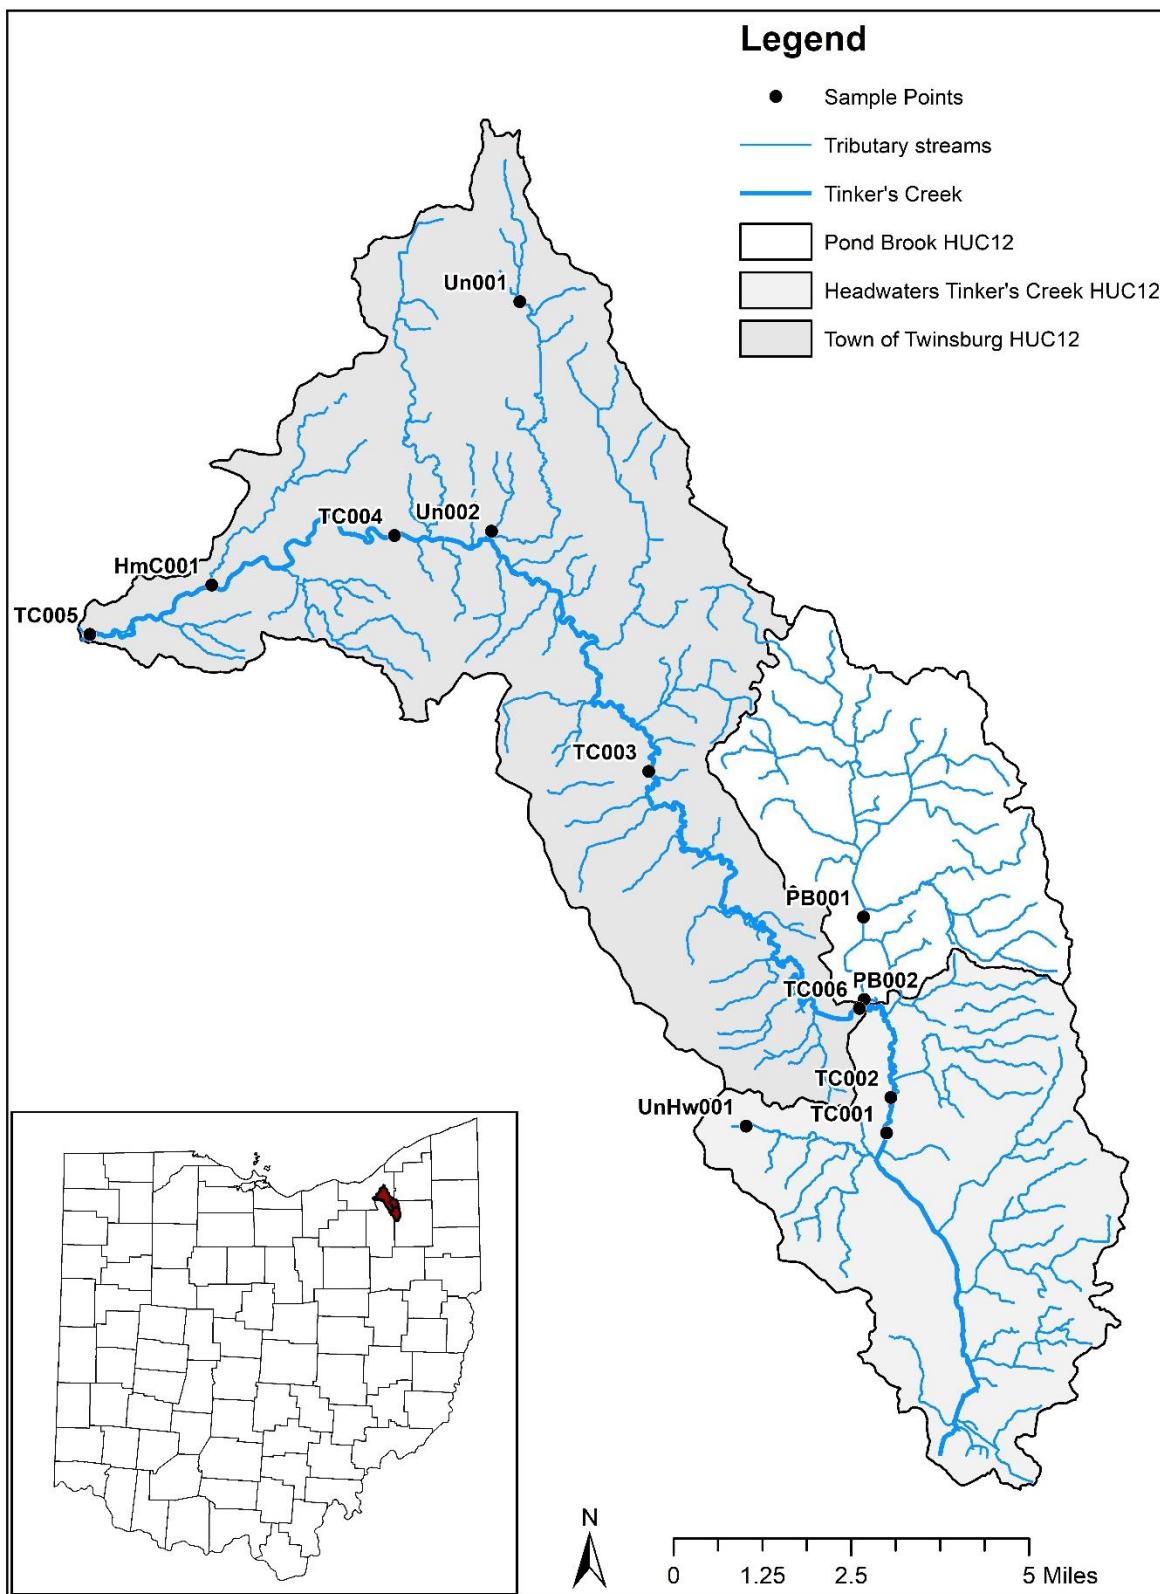
2019 Water Quality Sites Map

Using volunteer and staff assistance, TCWP sampled 12 sites between May and September, 2019 (Table 3). These sites are located throughout the watershed from the headwaters to the confluence of Tinker's Creek and the Cuyahoga River. A map of these sites is provided on page 9. Of these 12 sites, two sites were undergoing stream restoration projects in 2019 (Bedford Heights Bus Garage and Hudson-Tenbroeck Project).

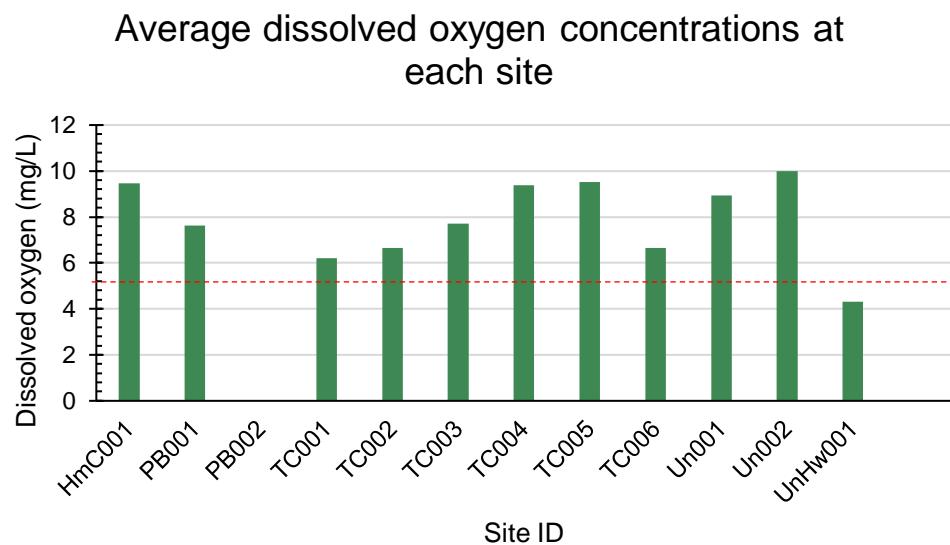
Figure 1: Average dissolved oxygen concentrations at each sampling site

In Tinker's Creek watershed, all but one sampling site meets and exceeds this 5 mg/L dissolved oxygen threshold (Figure 1). Only Darrow Road Park (UnHw001) failed to meet this threshold with an average dissolved oxygen concentration of 4.32 mg/L.

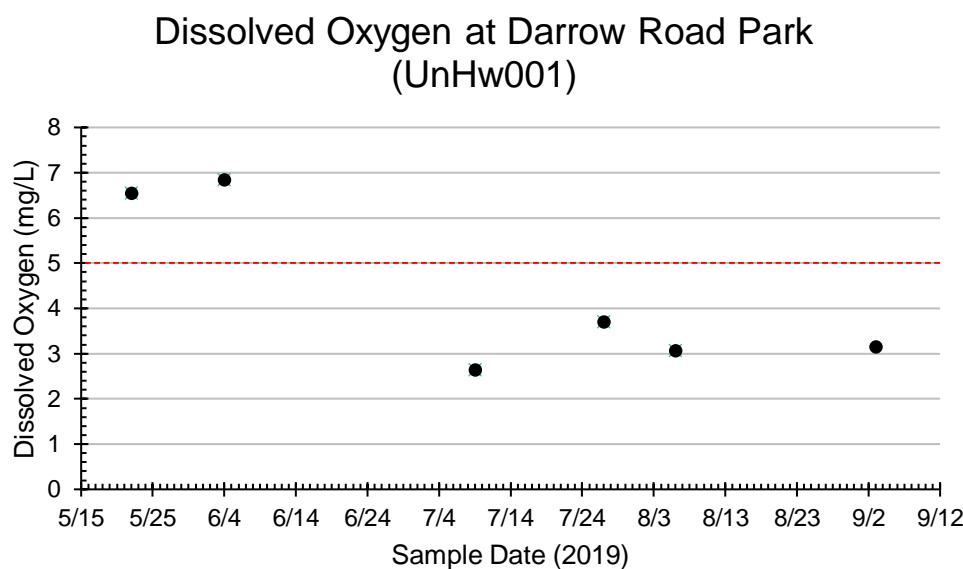
Figure 2: Dissolved oxygen concentrations at Darrow Road Park

Over the course of the sampling period, dissolved oxygen concentrations at Darrow Road Park decreased (Figure 2). In May and early June, dissolved oxygen concentrations exceeded targets, remaining between 6 and 7 mg/L. However, dissolved oxygen concentrations rapidly decreased to 2.64 mg/L by July 9. These low dissolved oxygen concentrations may be a result of decreased flow and warmer temperatures. As summer heats up, more evaporation occurs in streams, causing lower flows that may move more slowly. Slow moving, warmer water tends to have lower dissolved oxygen concentrations than rapidly moving, cold water. However, because flow or discharge was not measured during the 2019 field season, the exact cause of decreased dissolved oxygen concentrations is not yet known.

This year's water quality monitoring program also indicates poor water quality at Darrow Road Park. Historically, this unnamed tributary was once a ditch to convey water away from nearby homes. Now, this tributary has low dissolved oxygen, high TSS, and high nutrient concentrations. Additionally, flow is often very low and slow in this tributary, potentially causing sedimentation within the channel. TCWP recommends restorative actions at this site, including but not limited to increased floodplain connection, wetland restoration, and in-stream habitat improvements. TCWP has started working with Friends of Hudson Parks and the City of Hudson to develop an action plan at this site.

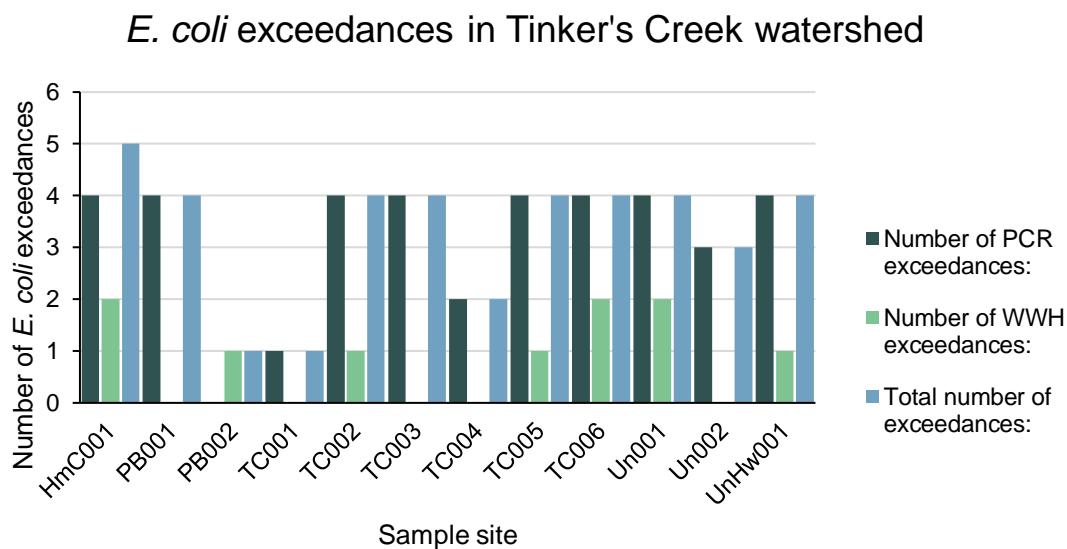
Figure 3: Number of *E. coli* water quality criteria exceedances in the watershed

E. coli concentrations vary greatly throughout Tinker's Creek watershed. During the 2019 sampling season, *E. coli* concentrations ranged from 10 cfu/100 mL to 12,000 cfu/100 mL. At most sites in the watershed, geometric mean *E. coli* concentrations consistently exceeded PCR criteria (Figure 3). Four sites, Hemlock Creek Picnic Area (HmC001), Pond Brook upstream of confluence (PB002), Tinker's Creek at Bissell (TC006), and Highland Woods apartments (Un001), exceeded *E. coli* criteria in 100% of samples taken this year (Figure 4). However, because only one sample was taken at PB002, it is unsure if high *E. coli* concentrations are a recurring occurrence at this

site. The exact cause of these exceedances is not known, but TCWP recommends that communities in the watershed keep up with their minimum control measure #3 illicit discharge detection and elimination (MCM#3, IDDE) requirements under their National Pollutant Discharge Elimination System (NPDES) permit to ensure that no illegal connections to the storm sewers are present. TCWP also educates the public about the importance of best management practices, like picking up after our pets on walks, in protecting local water quality.

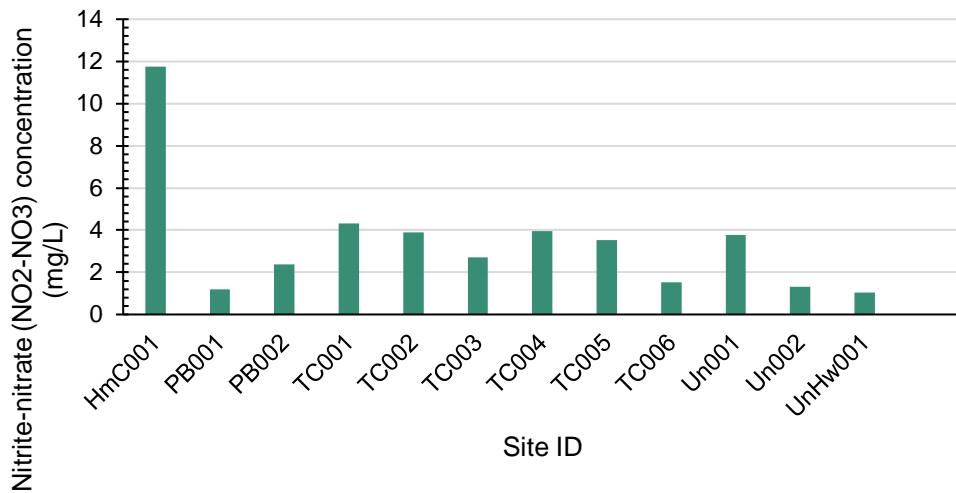
Figure 5: Average nitrite and nitrate concentrations at each sampling site

Average nitrite and nitrate concentrations were highest in Hemlock Creek Picnic Area (HmC001) (Figure 5). At HmC001, nitrite and nitrate concentrations were consistently high over the course of the sampling period, and the average nitrite and nitrate concentrations were significantly higher at HmC001 than all other sites. This may indicate nutrient pollution upstream of this site (Figure 6).

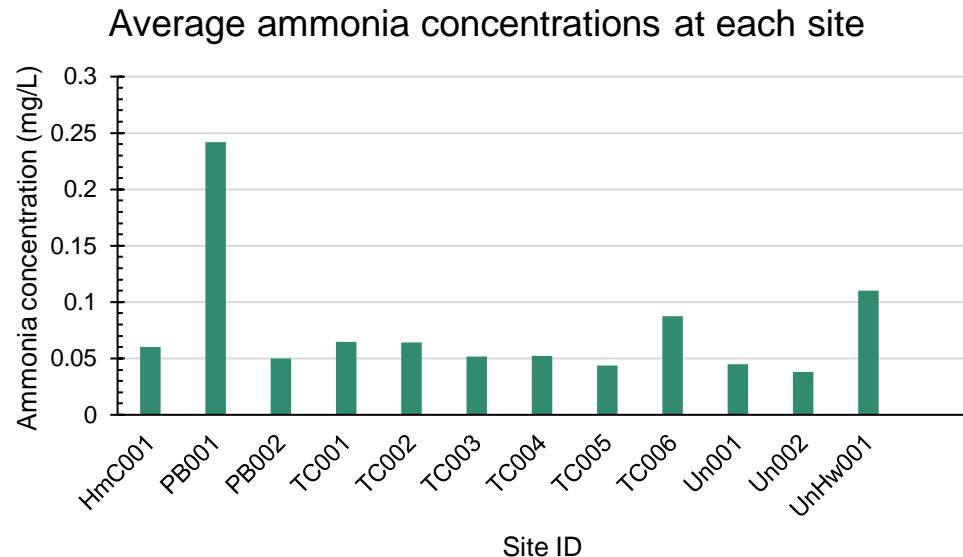
Figure 7: Average ammonia concentrations at each site

Ammonia concentrations at each site remained relatively low, with the maximum observed concentration over the study period occurring on September 19 at Liberty Park Pond Brook Conservation Area (PB001). On average, ammonia concentrations remained below 0.12 mg/L at

all other sites (Figure 7). No significant trends have been observed from these measured ammonia concentrations in Tinker's Creek watershed so far.

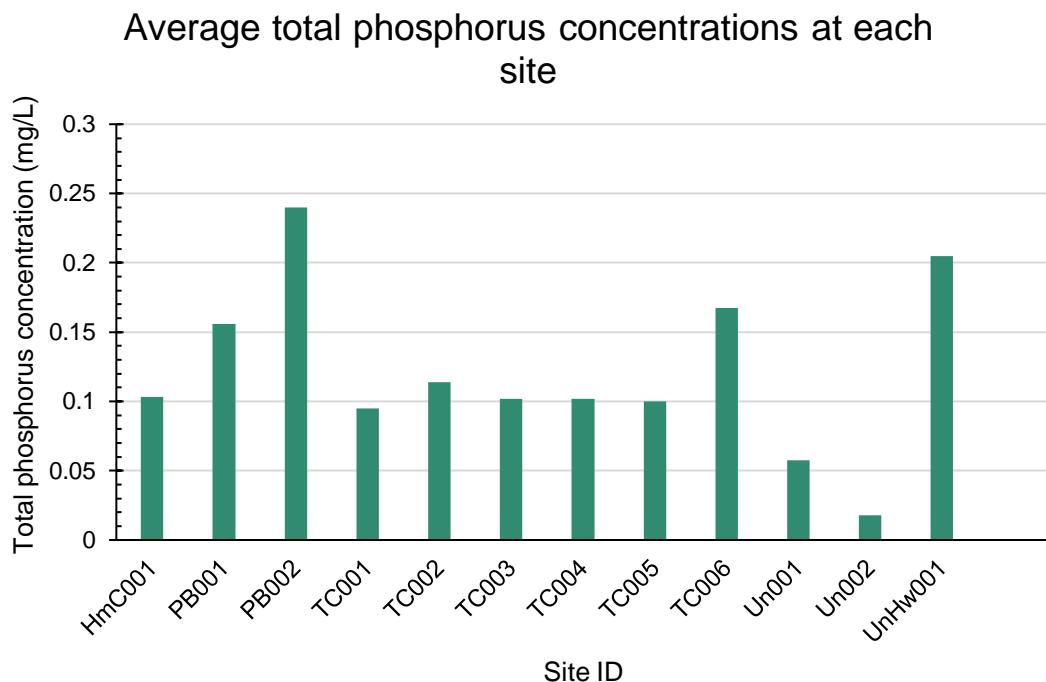
Figure 8: Average total phosphorus concentrations at each site

Total phosphorus concentrations in Tinker's Creek were low within normal ranges at all sites throughout the sampling period. On average, total phosphorus concentrations remained below 0.25 mg/L (Figure 8). The highest recorded concentrations of total phosphorus occurred on September 3 at Darrow Road Park (UnHw001), measuring 0.33 mg/L. Overall, no trends have been observed using this data relative to phosphorus concentrations in the watershed.

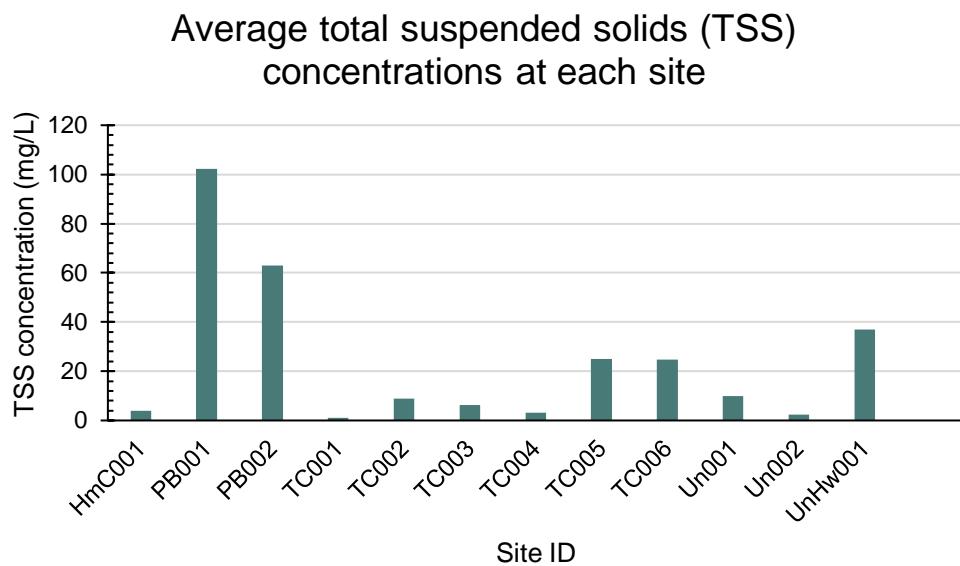
Figure 9: Average total suspended solids concentrations at each site

On average, TSS concentrations were highest at Liberty Park Pond Brook Conservation area (PB001) (Figure 9). However, this data is highly skewed by the September 19 sampling event at which TSS was measured at 480 mg/L. Prior to September 19, the highest recorded TSS value at PB001 was 12 mg/L, so this September sampling event may be an outlier. Pond Brook upstream of confluence (PB002) also experience high average TSS values, but because only one sample was collected at this site during 2019, TCWP is unable to determine if this is a recurring trend. TSS was also higher on average at Tinker's Creek Aqueduct (TC005), Tinker's Creek at Bissell (TC006), and Darrow Road Park (UnHw001). The average TSS at TC005 was skewed by the June 6 sampling event, during which TSS was measured at 110 mg/L. On June 5, heavy rains

occurred, affecting water quality at this site. TSS was consistently high at TC006, on the other hand. TC006 is located just downstream of the confluence of Tinker's Creek Headwaters and Pond Brook subwatersheds, so this site is expected to experience periods of high suspended matter. Because UnHw001 is located in a shallow tributary of Tinker's Creek, however, data suggests that Darrow Road Park may be experiencing sedimentation or stormwater pollution.
